Manhole Inspection Summary

Manhole # S43SS_005MH

Insp Date: **2/22/07 2:19 PM**

Location Address: **1555 HOMESTEAD ST**

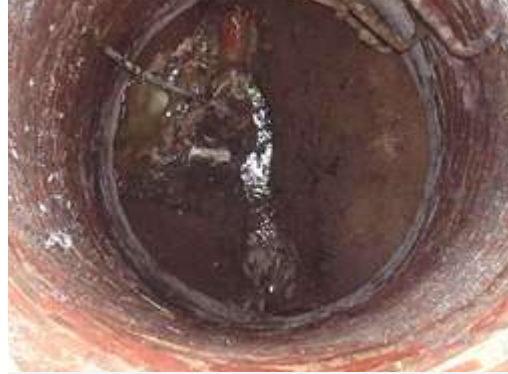
Top View

Evidence of surcharge - Bench debris. Channel debris. Bench and Channel root intrusion.

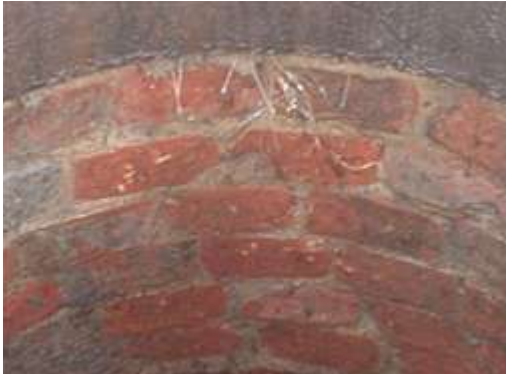
Defect

Frame leaks. Adjustment root intrusion and infiltration.

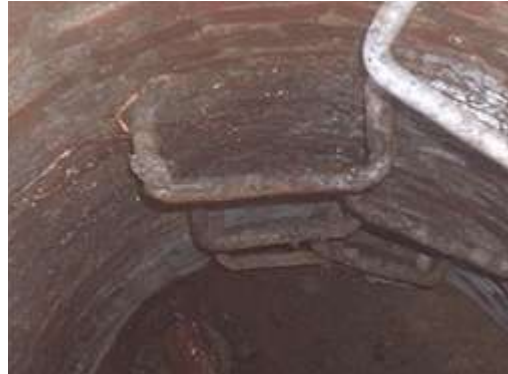
Defect

Corroded steps.

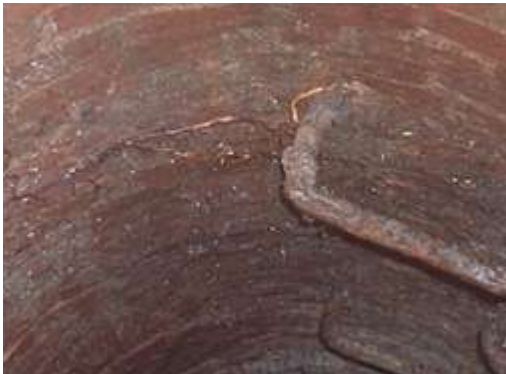
Defect

Corbel root intrusion and infiltration.

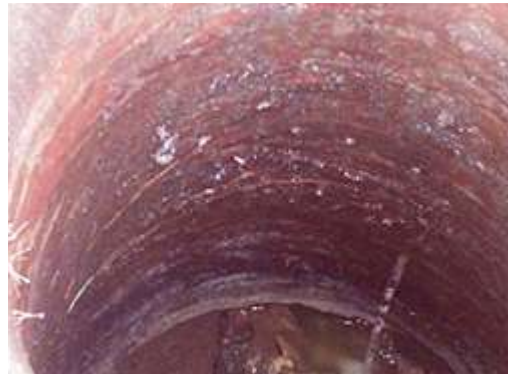
Defect

Adjustment root intrusion and infiltration. Corbel and Barrel infiltration.

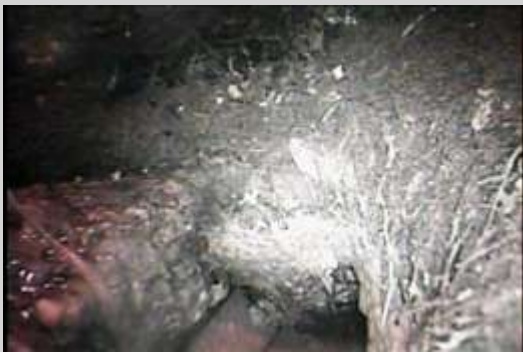
8 in. Circular Gravity Sewer Pipe Out @ 12 O'Clock

Barrel root intrusion and infiltration. Channel deterioration.

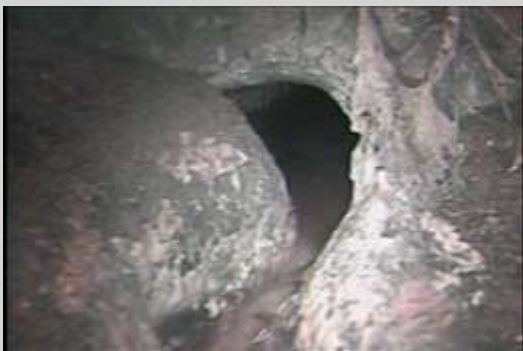
8 in. Circular Gravity Sewer Pipe In @ 6 O'Clock

Bench and channel root intrusion.

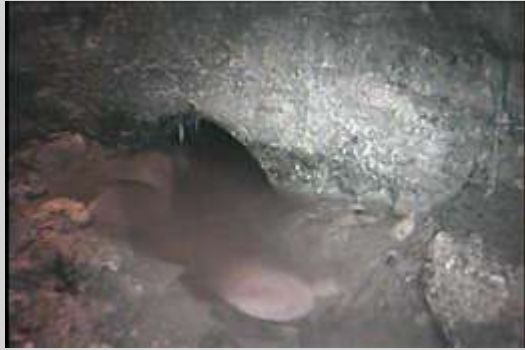
Pipe In @ 9 O'Clock

Barrel root intrusion.

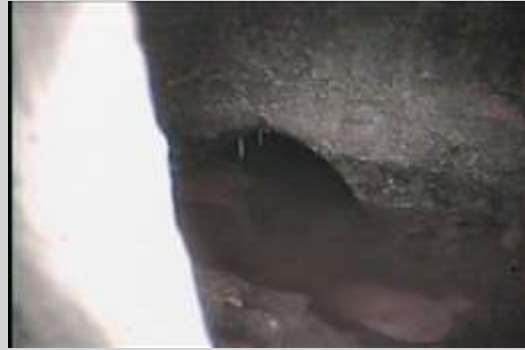
Drop In @ 9 O'Clock

Barrel infiltration.
